VIDEO PROBE INSPECTION OF ROOFBOLT HOLES AT KIDD CREEK MINE

G. Herget and B. Arjang

MRL 89-13 (TR)

FEBRUARY 1989

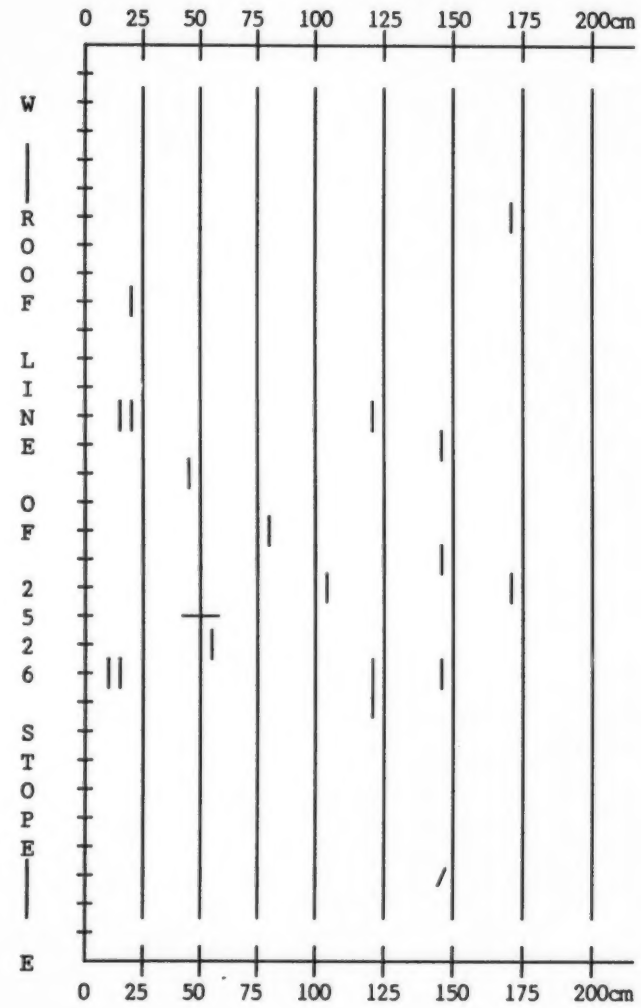
TABLE 1 - Swellex Borehole Inspection Summary for Kidd Creek Mine 2526 Stope U/C (Video tape Nr. 1)

1) minor cracking

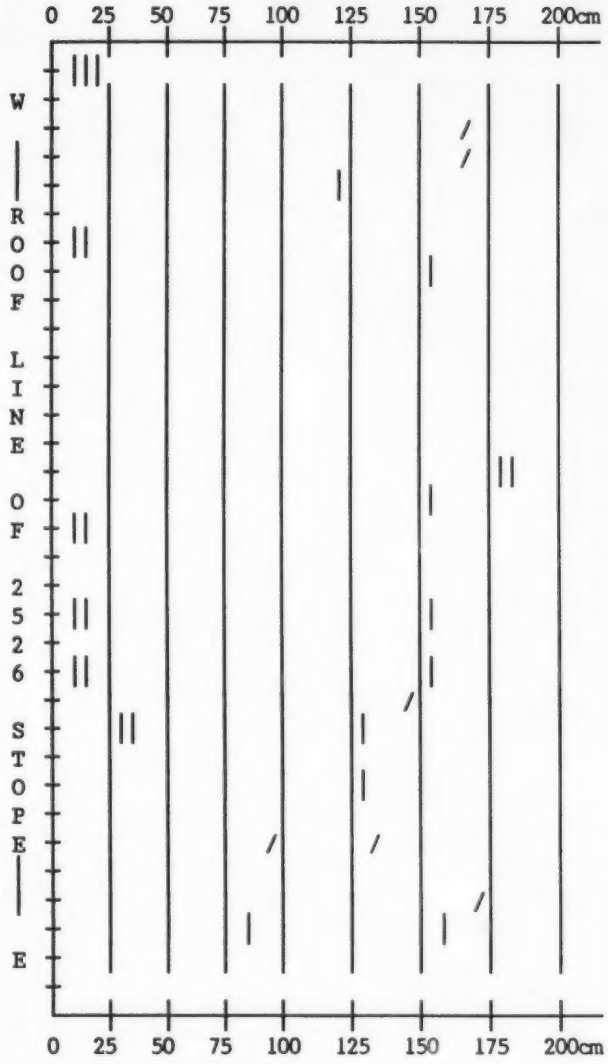
TABLE 1 (cont'd)

2) rough wall of collar
3) (2 runs), back of hole cracked (1724)
4) breakouts
5) rough wall

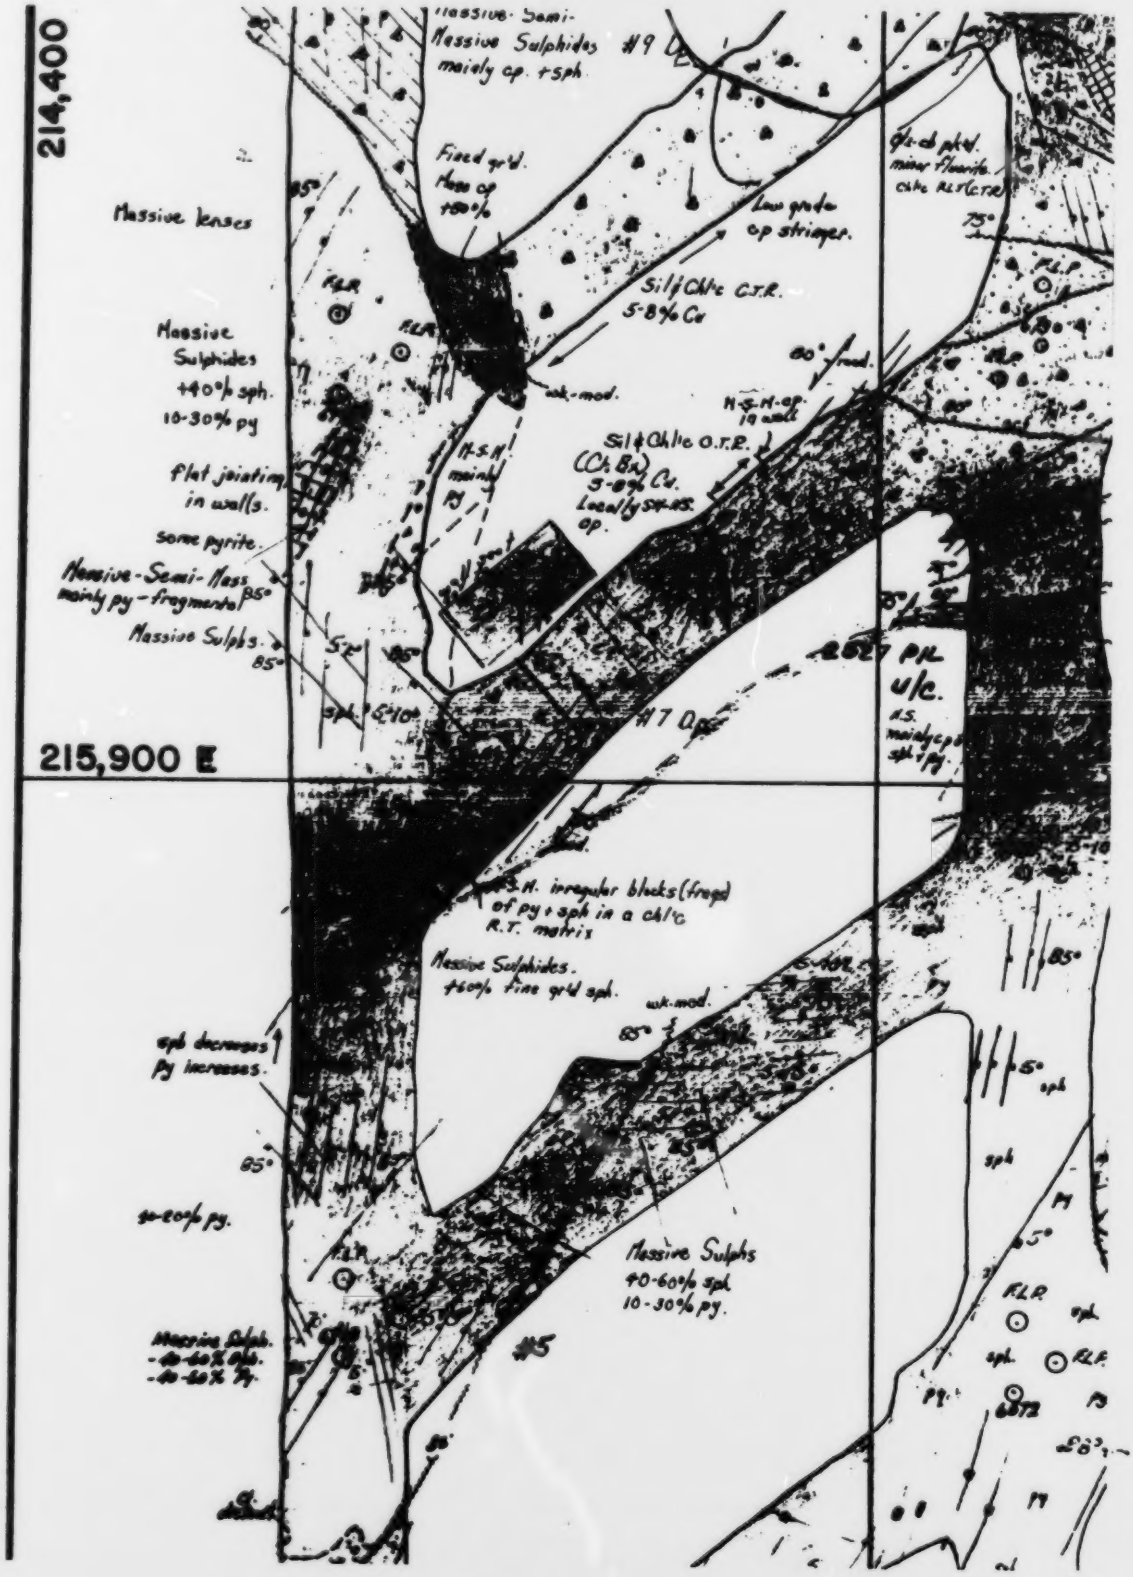
Fig. 5 - Geology of Swellex test site on 2500 level

Figure 5 shows the geology of the site provided by Kidd Creek mine. Nearly all the holes were located in massive sulfides consisting of yellow pyrite (FeS_2) and brown stringers or areas of sphalerite (ZnS). Only occasionaly the holes showed quartz veins. All holes were slightly fractured at the collar from blasting. In a number of places the roof required scaling. In total the rock mass is very competent and only occasionally do the borehole walls show small breakouts from micro cracking or some subhorizontal jointing. Only seven holes showed vertical fractures (Table 1).
